Inspection Report Minerals Regulatory Program Report Date February 15, 2006

Mine Name: Asphalt Ridge

Permit number: M/047/022

Operator Name: Uintah County Road Department

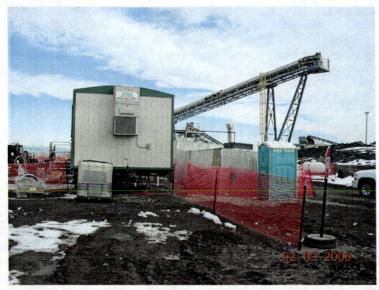
Photo 2. The trailer and some of the other facilities associated with the pilot operation. The conveyor is part of the existing processing operation.

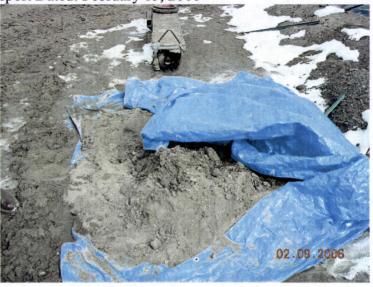
The processed sand is being stored on a tarp (Photo 3). I could smell hydrocarbons in the sand, and the people from Black Sands said this was because the sand had not been fully processed to recover all the volatile chemicals.

Photo 3. Waste sand.

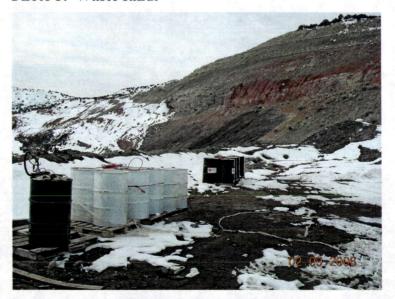
The tar sands processing operation uses hexane and pentane, and there were 10 barrels of pentane and five barrels of hexane on the site (Photo 4). These were not stored on a lined area, but overland flow would not leave the site. There were also some empty barrels. I confirmed that the Division of Water Quality will not require a permit for this operation, and they did not indicate a liner would be needed for the area where these chemicals are being stored. I also called Darrin Brown of the Tri-County Health Department to let him know about the operation.

Photo 4. Barrels of pentane and hexane.
